HOLLIDAYSBURG RESERVOIR

NDI I.D. NO: 522

PHASE I INSPECTION REPORT  
NATIONAL DAM INSPECTION PROGRAM

D'APPOLONIA CONSULTING ENGINEERS  
10 DUFF ROAD  
PITTSBURGH, PA. 15235  
JULY 1978

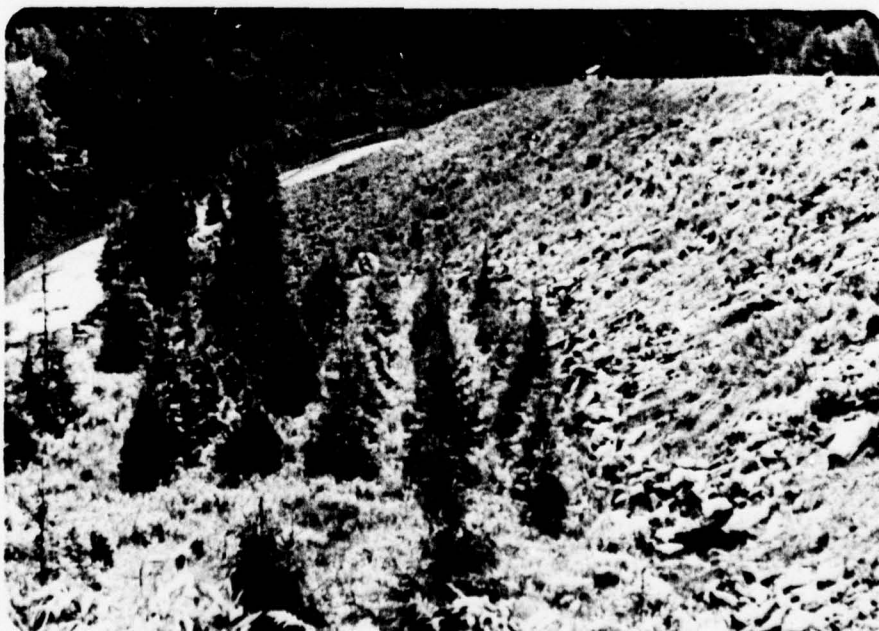
Downstream Face

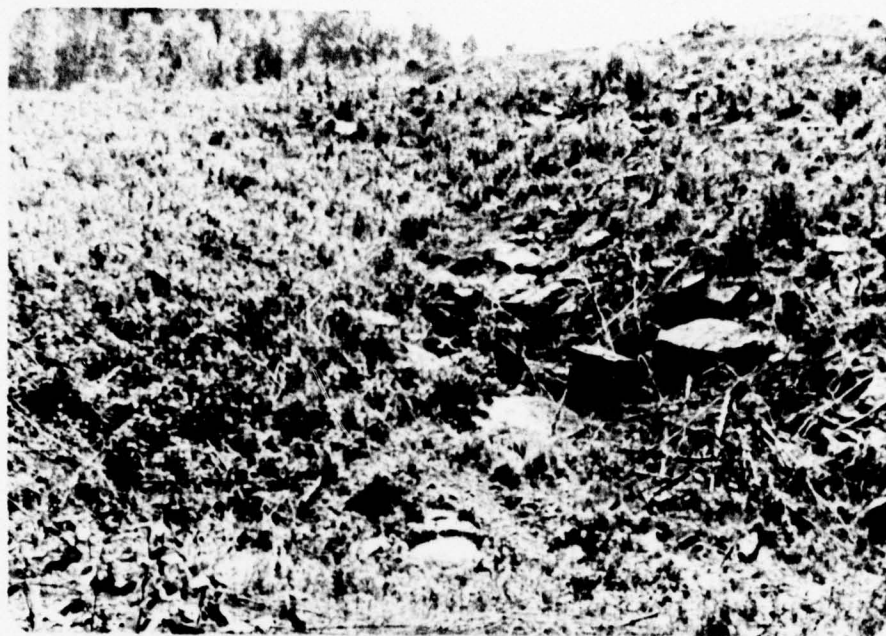
Photograph No. 1  
Right abutment.

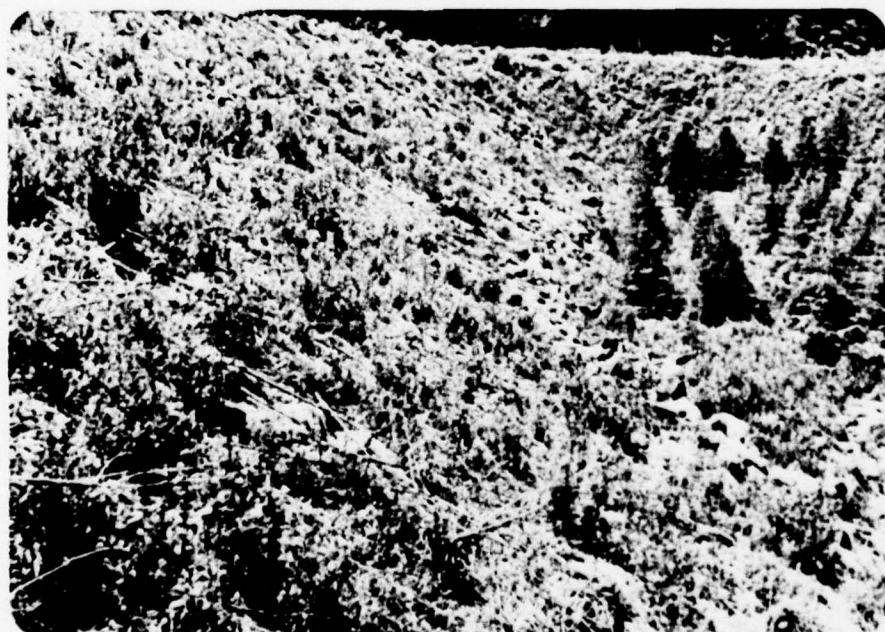
Photograph No. 2  
Left abutment.

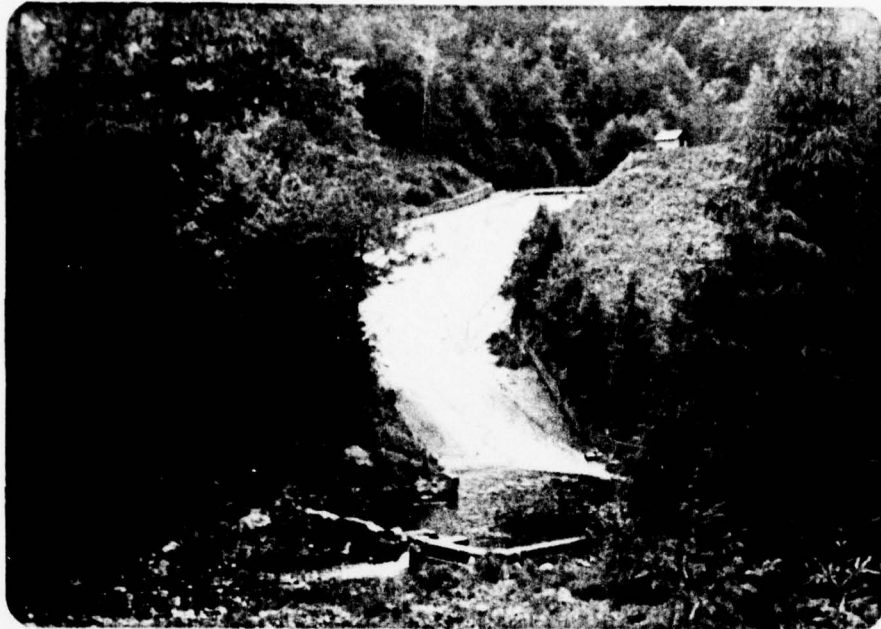
Photograph No. 3  
Spillway chute. (Note valve house on crest.)

3. It is recommended that the owner evaluate the need to install piezometers into the embankment.
4. The adequacy of riprap at the entrance channel of the spillway should be evaluated to determine if it provides sufficient protection against erosion of the embankment during high flows.
5. It is recommended that the owner provide around-the-clock surveillance during periods of unusually heavy runoff and develop a formal warning system to alert the downstream residents in the event of emergencies.
6. It is recommended that the owner be advised that the dam and appurtenant structures should be inspected regularly and properly maintained.

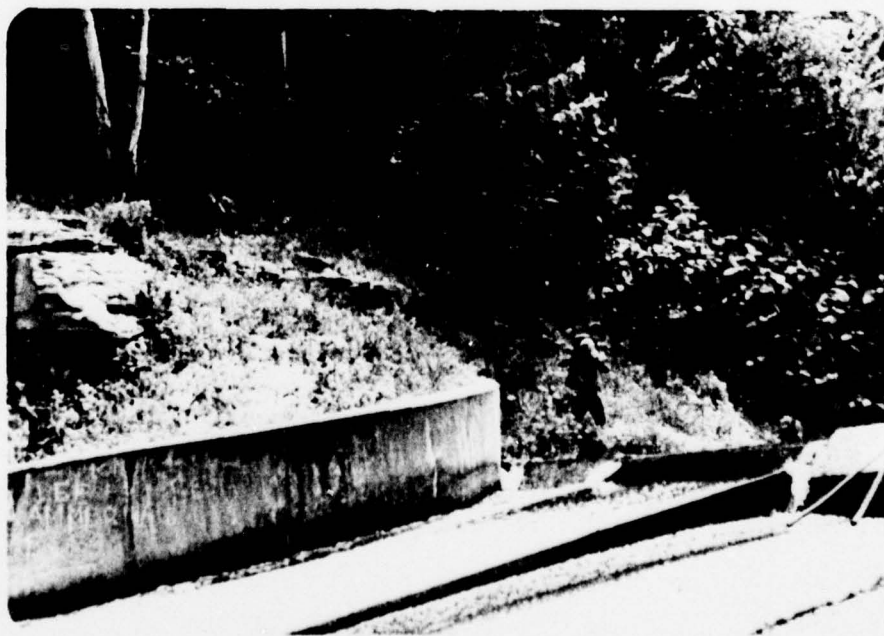
Photograph No. 4  
Spillway crest.

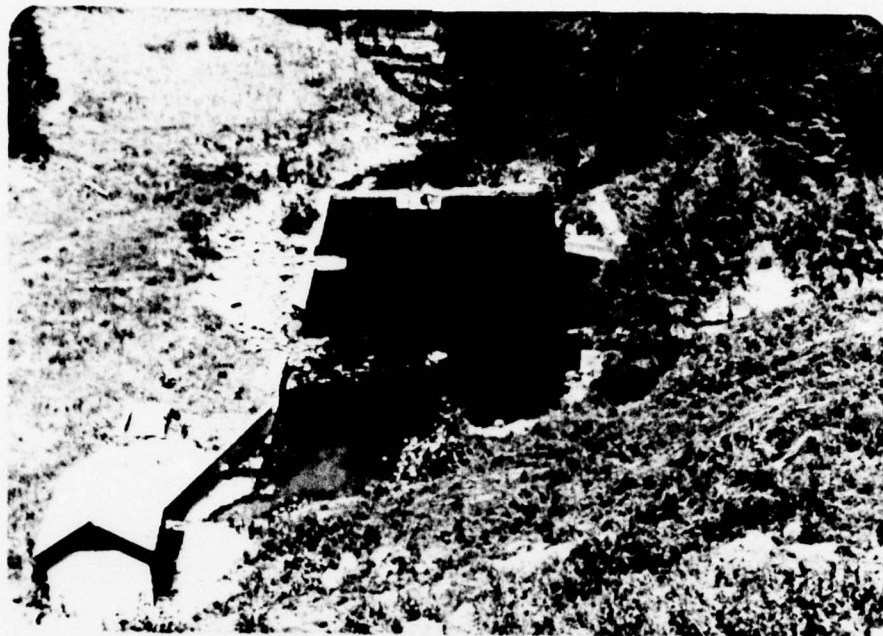
In general, the structures were found to be in good condition, except for erosion along the side of the plunge pool opposite the spillway discharge channel. However, this condition is not considered to be a problem at present.

Photograph No. 5  
Spillway and outlet pipe plunge pool.  
(Note valve house.)

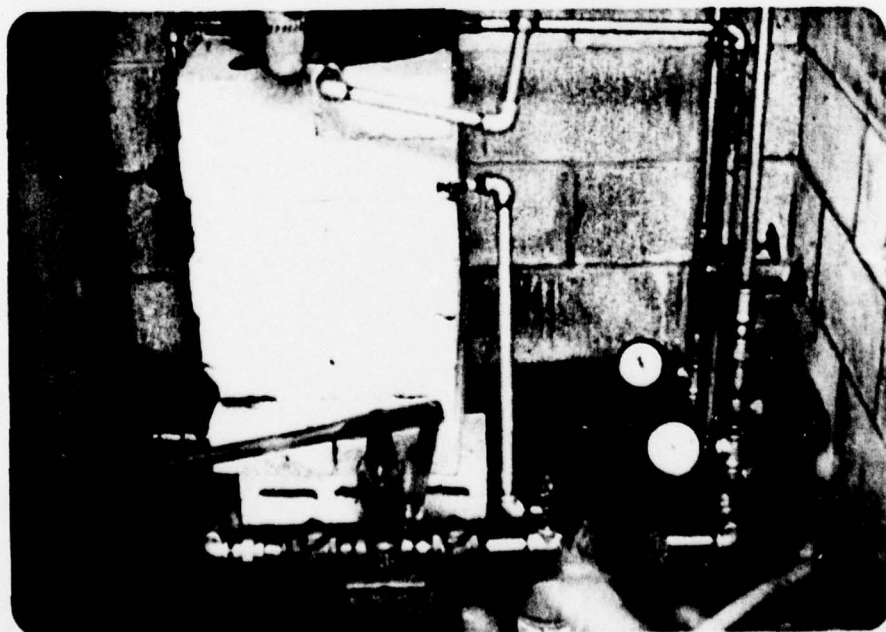
4.5 Evaluation. The overall maintenance condition of the dam is considered to be fair. The blow-off pipe gate controls should be immediately repaired to permit lowering of the reservoir. Channelization and monitoring of the seepages are required to determine that the seepage quantities are not increasing with time.

Photograph No. 6  
"Blow-off" pipe controls on crest valve house.

1. The owner should be advised to make appropriate repairs to the outlet pipe gates immediately.
2. The seepage at the toe of the dam and on the abutments should be monitored and recorded. Marshy areas below the toe of the dam should also be observed to determine that the conditions are not changing.

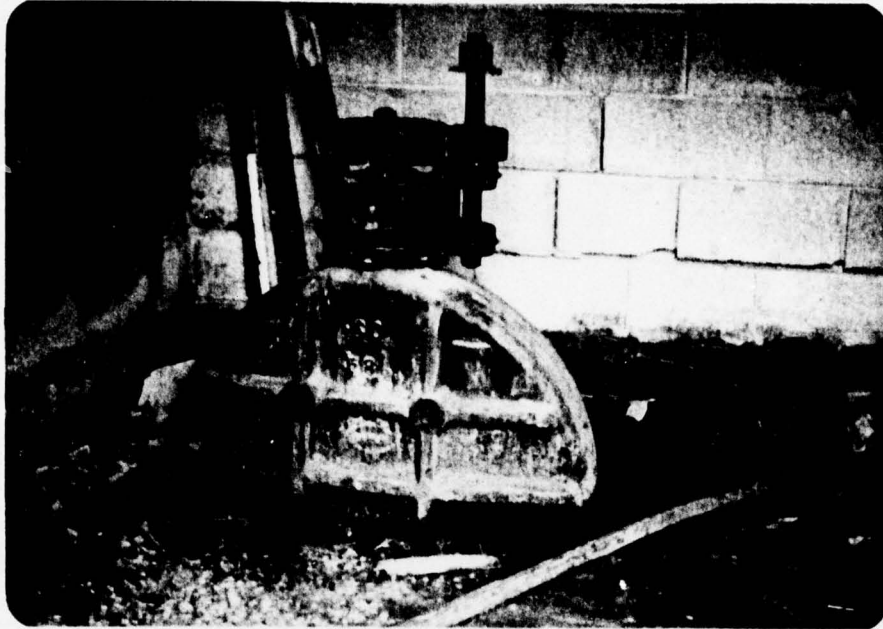
VISUAL EXAMINATION OF	OBSERVATIONS	REMARKS OR RECOMMENDATIONS
CRACKING AND SPALLING OF CONCRETE SURFACES IN OUTLET CONDUIT	OUTLET PIPE : 30-INCH CORRUGATED METAL PIPE. ONLY DISCHARGE END IS VISIBLE.	
INTAKE STRUCTURE	SUBMERGED NOT VISIBLE.	
OUTLET STRUCTURE	DRAIN PIPE DIRECTLY DISCHARGES INTO SPILLWAY PLUNGE POOL.	
OUTLET CHANNEL	NONE.	
EMERGENCY GATE	DAM TENDER REPORTED THAT THE OUTLET PIPE VALVE IS <u>NOT</u> FUNCTIONAL

Photograph No. 7  
"Blow-off" pipe valve in toe valve house.

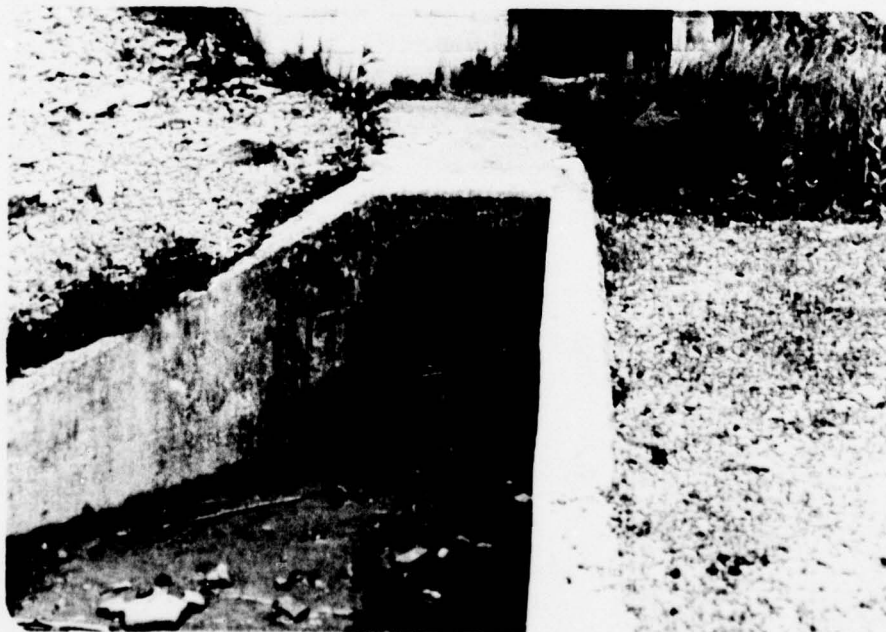
Photograph No. 8  
"Blow-off" pipe.

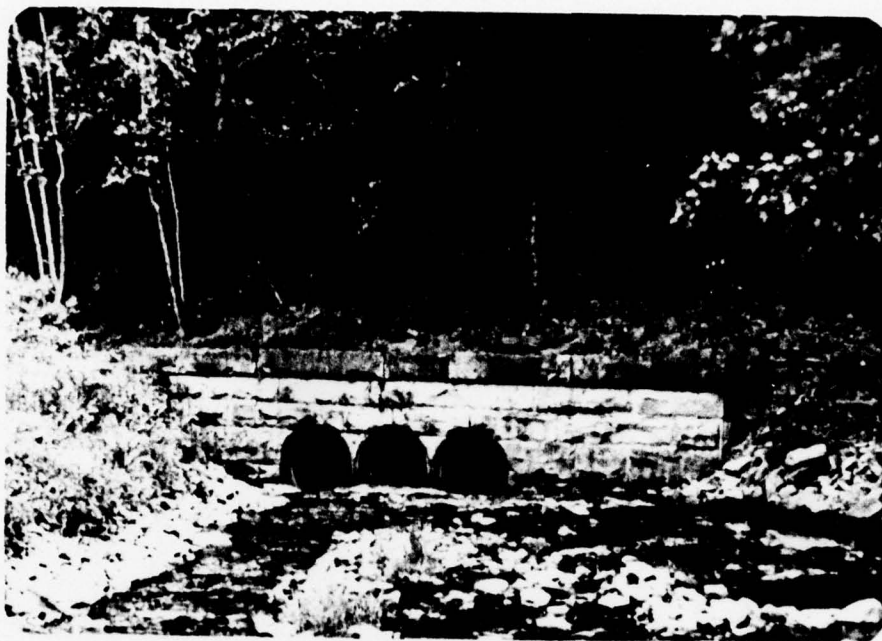
Photograph No. 9

Culverts under railroad embankment  
(500 feet downstream).

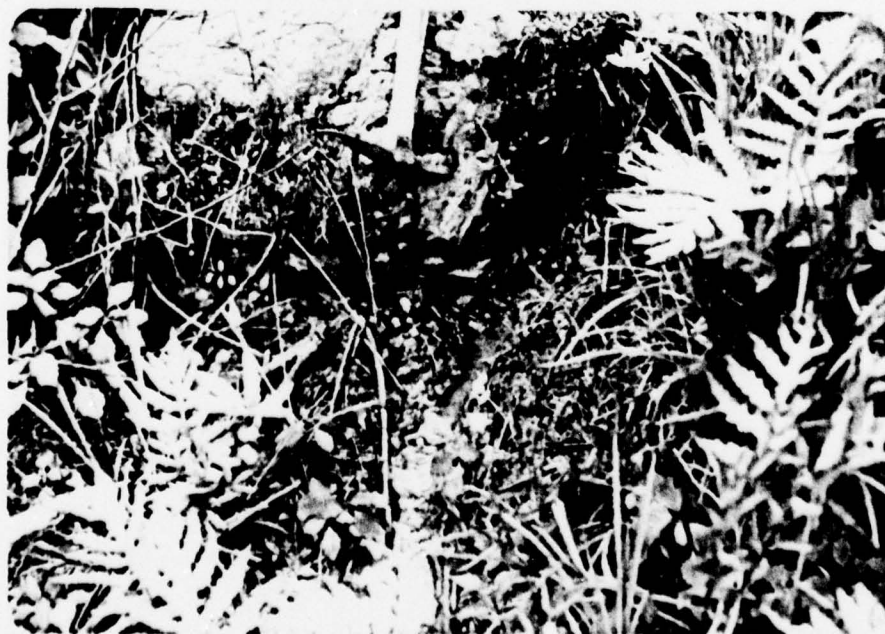
Photograph No. 10

1. Two seepage areas were found at the toe of the dam. The first was located near the left abutment. The seepage quantity was estimated to be about 5 to 10 gallons per minute. This seepage flowed along the toe for 15 to 20 feet and percolated back into the rock toe of the dam. The second seepage area along the toe was located to the left of the valve chamber at the toe of the dam. This seepage formed a swampy area extending along the side of the spillway plunge pool and discharging into the stream and plunge pool. The quantity of this seepage was estimated to be 5 gallons per minute. Both seeps were observed to be clear with no indication of internal erosion.

Seepage at toe.

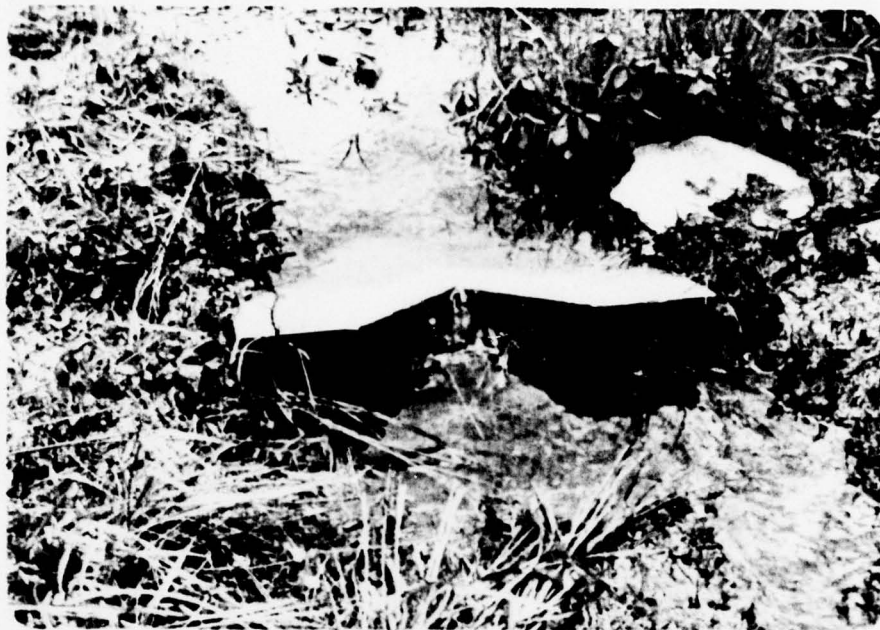
Photograph No. 11  
Total seepage from toe.

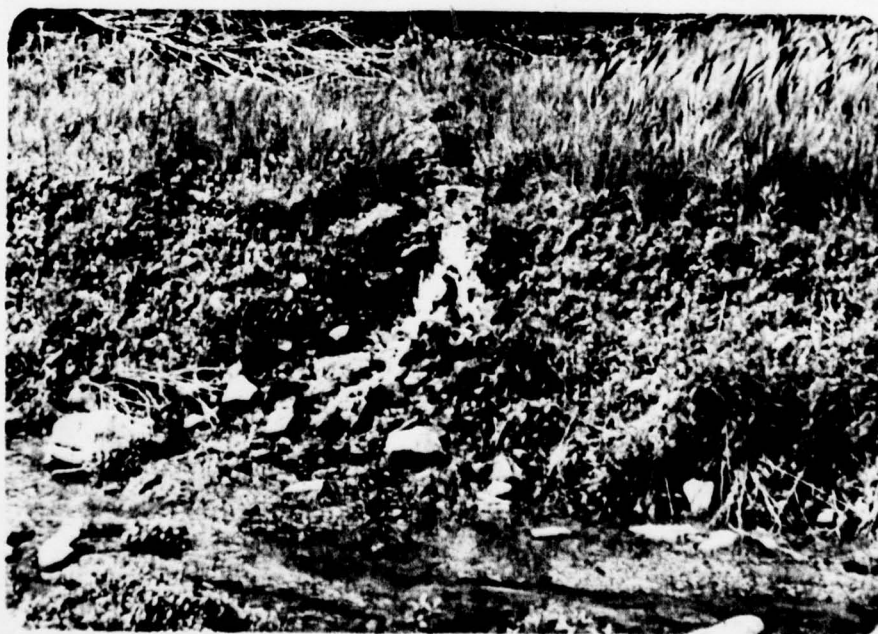
2. One seepage area was found on the right abutment at the toe level. This seepage is located on the left side of the spillway channel and was estimated to be 5 gallons per minute. The seepage was clear.
3. Two springs were found approximately 200 feet downstream from the toe on the left side of the stream channel. Total discharge from the springs was estimated to be 100 gallons per minute.
4. Riprap on the upstream slope of the dam was significantly weathered. No riprap was found on a portion of the upstream slope immediately adjacent the spillway.

Photograph No. 12  
Spring on left abutment.
